**LTPP Seasonal Monitoring
Program**
Site Monitoring Suspension
Status Report
Section 251002
Chicopee, Massachusetts

SEASONAL MONITORING PROGRAM SUSPENSION STATUS REPORT MASSACHUSETTS SECTION 251002

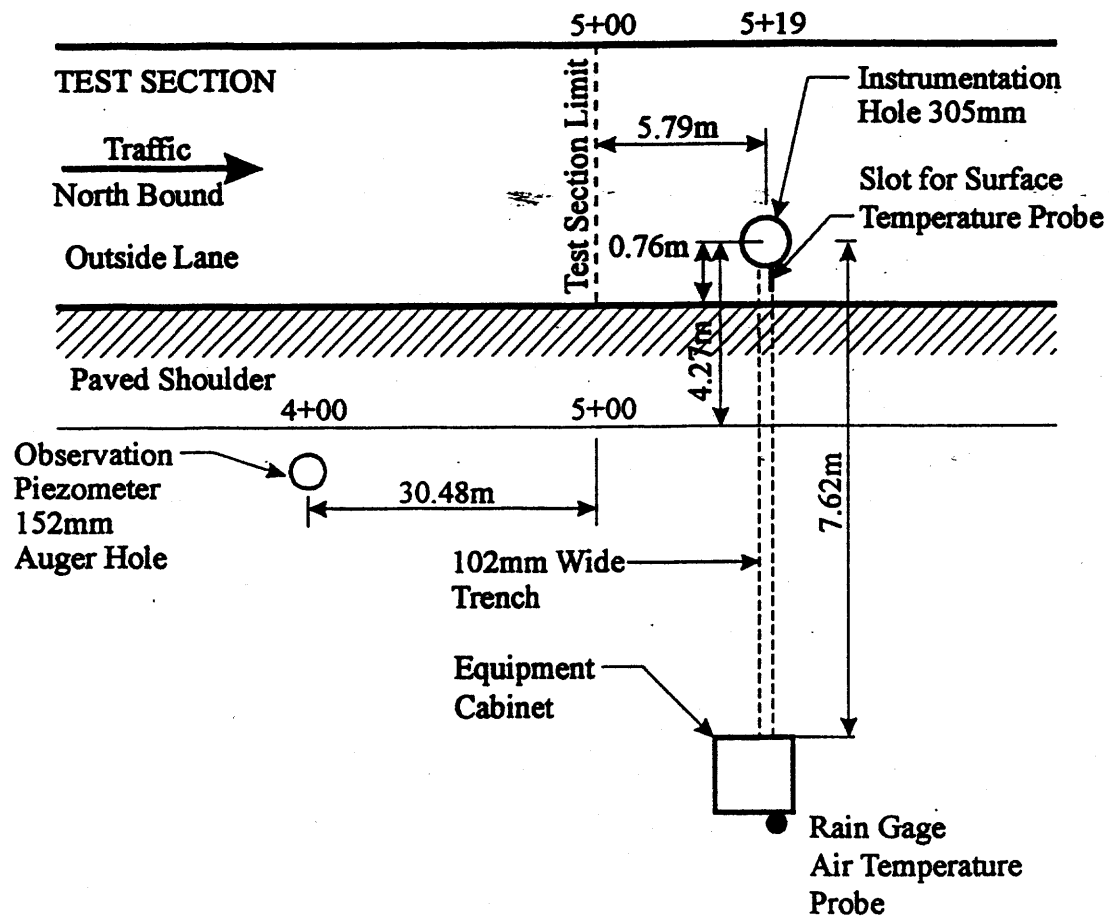
Figure 1. Location for Seasonal Monitoring Instrumentation Installed at GPS 251002

Figure 1 shows the locations of the installed instrumentation at the site. The instrumentation hole is at Station 5+19 and the piezometer is at Station 4+00. Table 2 gives the elevations of the portion of test section 251002 that was used for elevation measurements. All offsets are from the PK nails found at the outside pavement edge.

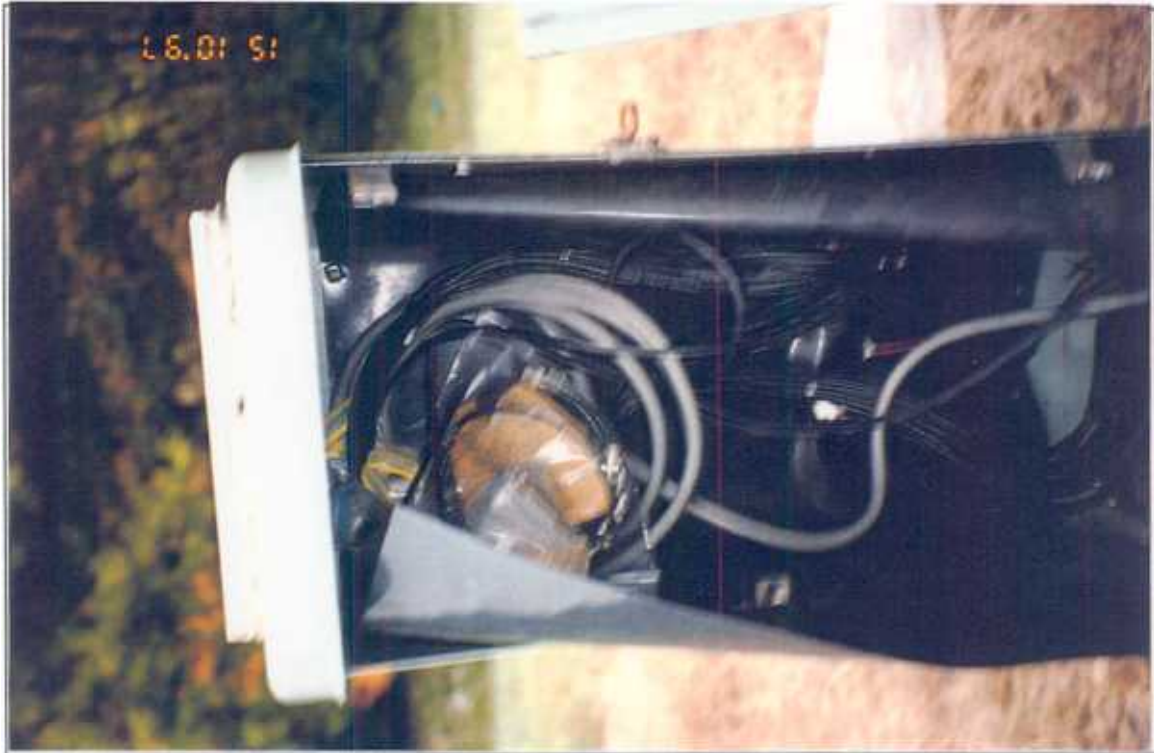
Inside Equipment Cabinet, Seasonal Site 251002 - Oct. 1997, after Suspension Activities

The solar panel was disconnected. After all wires to the control panel were disconnected, the panel was detached from the equipment cabinet along with the CR10 datalogger, terminal strip and battery pack. The TDR cables, resistivity cable and MRC lead wires were sprayed with an anti-corrosive compound and sealed with desiccant packs in air tight bags. All cables/wires were hung up high inside the equipment cabinet. After the last piezometer reading was recorded, the pipe was cleaned and sealed with grease. The access cover and seat were cleaned and lubricated before being covered and brought up to grade with native soil.

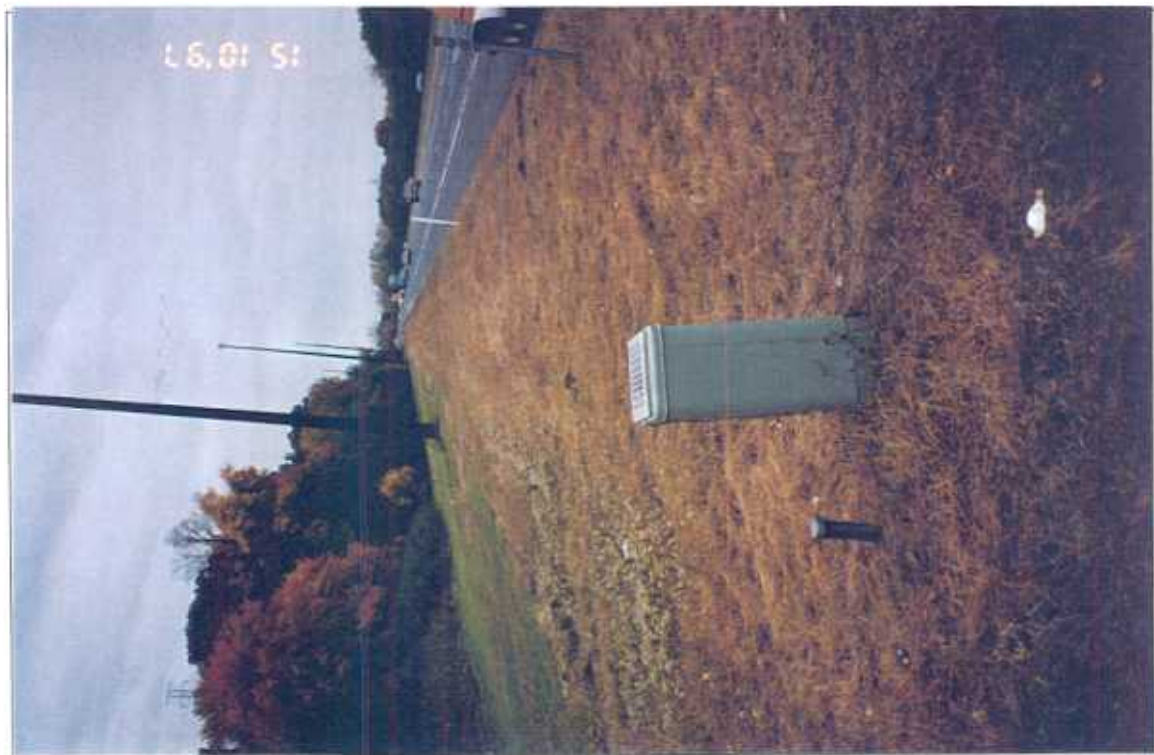
Equipment Cabinet, Lower portion of inst. pole, Seasonal Site 251002 - Oct. 1997, after Suspension Activities

The air temperature probe, tipping bucket, and the upper part of the support pole were dismantled. The lead wires from the air temperature probe and tipping bucket were removed from the cabinet and sprayed with an anti-corrosive compound. The above ground conduit from the pole to the equipment cabinet was removed and the resulting hole in the back of the cabinet sealed. The bottom part of the support pole was cleaned and lubricated prior to installing the end cap.
